# *Surprises at Every Turn*

An Architectural Tour of Old St. Andrew's

**PAUL PORWOLL**

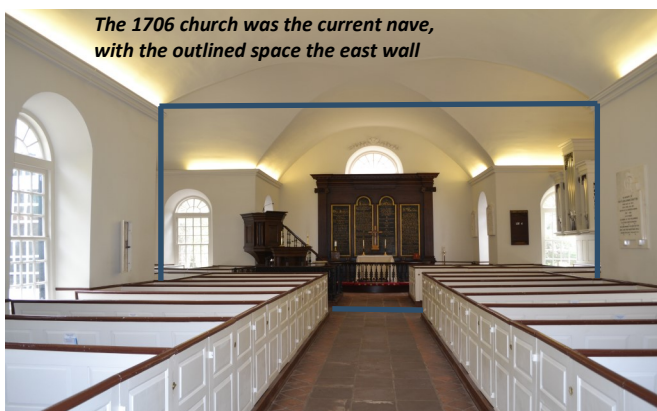
***The 1706 church was the current nave,  
with the outlined space the east wall***

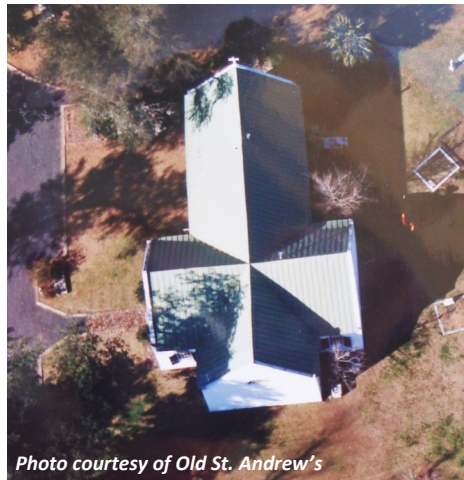
Cruciform churches were uncommon in England but widely found in Barbados, home of many of the earliest Carolina settlers. Cruciform-design buildings with lower walls were found to withstand hurricane-force winds better than traditional plans.

An aerial photograph illustrates the St. Andrew's cruciform design.

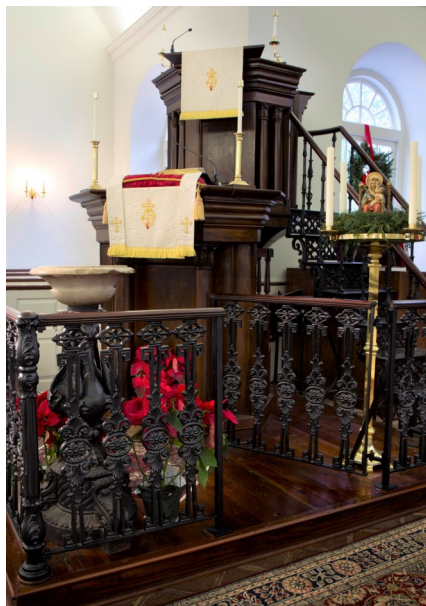
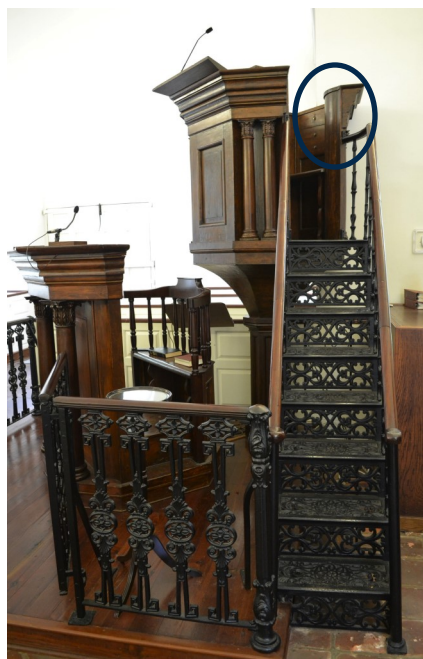
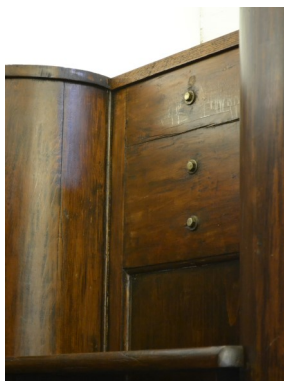
Also notice the three bolts that anchor the back of the pulpit to the chancel wall. Workers discovered during the 2004 restoration that termites had nearly eaten away the base of the pulpit. They repaired the damaged wood, cemented the base into place, and added the bolts for extra stability.

***Bolting the pulpit to the wall: circled (top) and detail (left)***

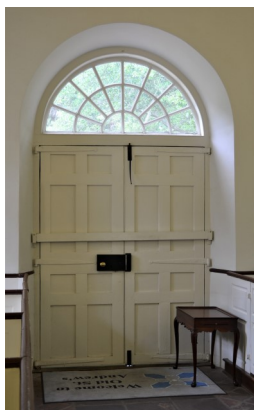
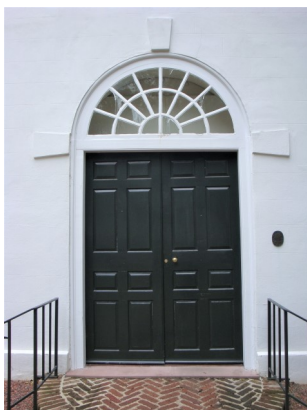
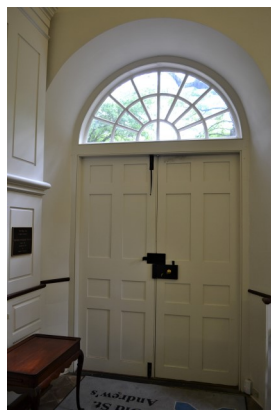
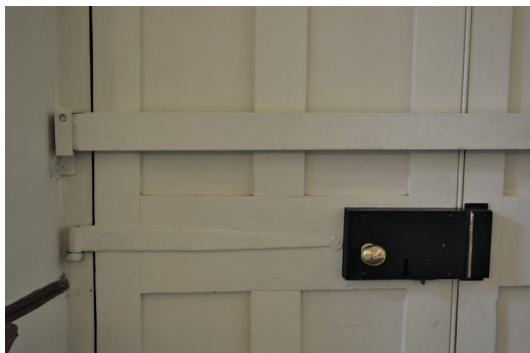
Standing at the crossing of the aisles, you'll see two of the three doors at either end of the transept. This three-door design dates to 1723. The main entrance is at the west end facing Magee House. Used less often are the south door with its handicap ramp facing Ashley River Road and the north door facing most of the oldest gravestones. The north door has the oldest hardware and a locking bar to prevent intrusion through the most hidden of the entrances. The south door was recently updated.

*Church doors: north end (left), west end exterior (center), south end (right), and close-up of hardware and locking bar on north door (bottom)*

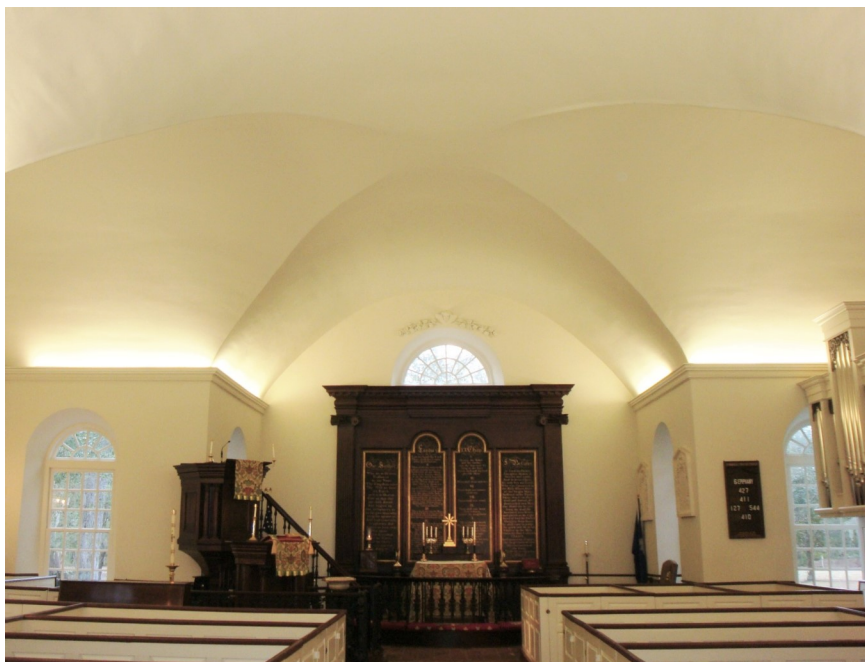
Now look up. The soaring barrel-vaulted ceiling dates its beginning to the 1723 expansion. Architectural historian Louis Nelson envisioned its effect on devout parishioner Dr. Edward Brailsford, whose devotional book he kept from 1710 to 1744 is the oldest surviving religious document relating to the church. “For Brailsford,” wrote Nelson, “the church in rural St. Andrew’s Parish, South Carolina, was home of the perfect, sovereign, triune God. . . . Once inside, the lofty vaulted ceiling lifted Edward’s spirit; it seemed to him to be the cope of heaven itself.”

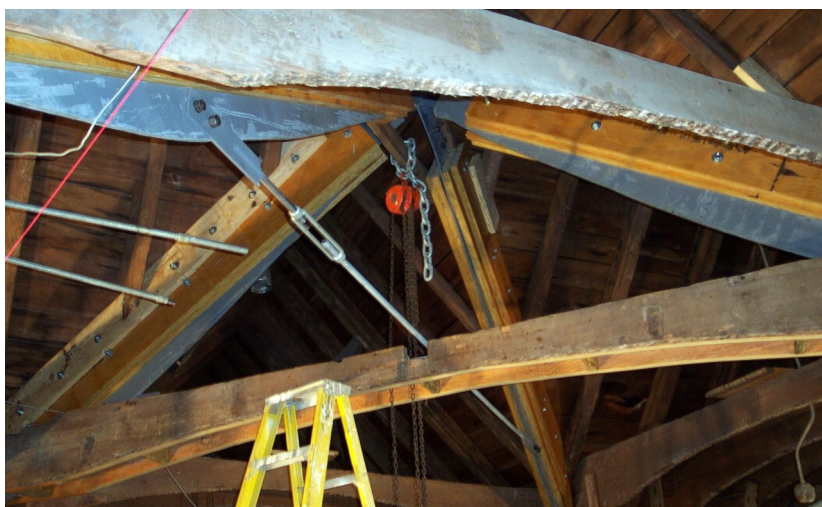
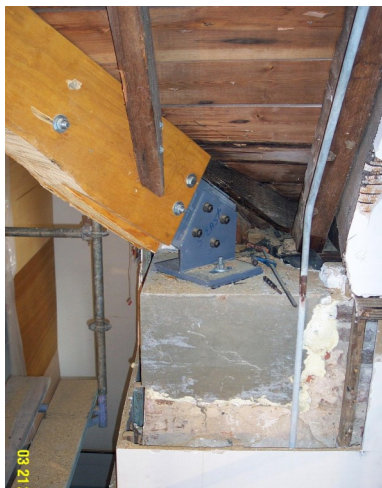
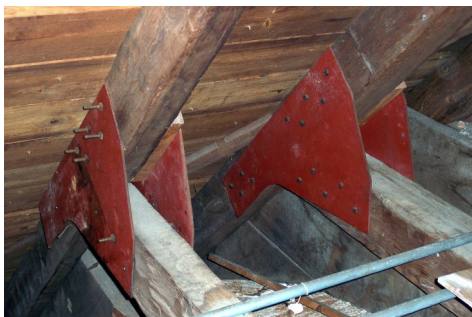
While many parts of the church were repaired during this restoration, it was the roof rafter system that presented the biggest challenge and cost the most money. Plaster was removed from the entire ceiling. New concrete footings were poured. In a number of places, steel plates were sandwiched between high strength wood to form new rafters; these were placed alongside the eighteenth-century rafters. Steel collar ties were then added. When it was all finished, the church was once again safe for occupancy.

*Repairs to the roof rafters: top and left, during the 2004–5 restoration; right, addition of steel gusset plates in 1960; courtesy of Richard Marks Restorations and Old St. Andrew's*

What the ceiling hides takes us into the very bones of the church. Concealed behind it are an intricate series of roof rafters and collar ties dating to the 1760s. Each hand-hewn rafter was mated to the other. Carpenters inscribed the top of each pair with the same roman numeral (I, II, III . . .) to ensure proper fit.

would close the church for repairs for a year and a half. Many rafters had pulled away from their footings. Many collar ties had separated from their rafters. It was not safe to be inside the church. Rector George Tompkins was heard to have said to a parishioner, “The church seemed to be held together by paint and the grace of God.”

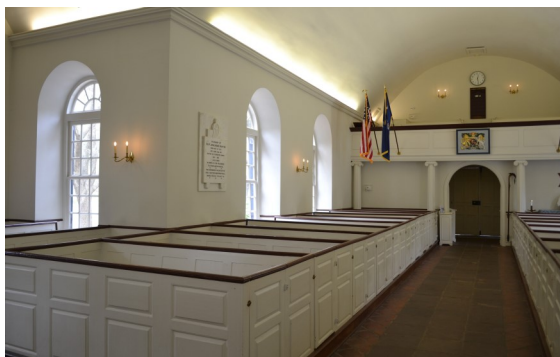
In 1960 steel gusset plates were installed to twenty-six sets of rafters to strengthen them. At the end of the twentieth century as the vestry was contemplating the new millennium and the church’s three hundredth anniversary in 2006, structural engineers were hired to check out the church and give it their seal of approval. Be careful what you ask for!

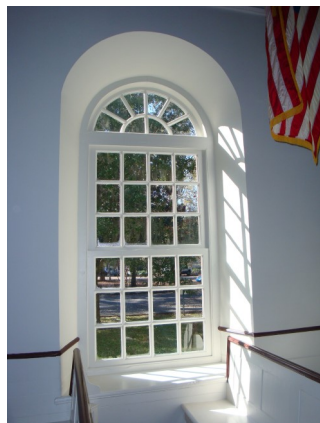
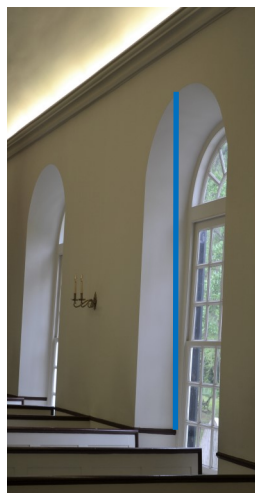
They tilt outwards, markedly so. This is a result of two things: the 1886 earthquake and more than three centuries of the heavy roof pushing down on the brick walls. Yes, it's safe to be inside the church, thanks to the skill of twenty-first-century craftsmen who did a remarkable job stabilizing the roof.

*Colonial-style compass-headed window (top) and marked deflection when viewed at the crossing of the aisles (bottom)*

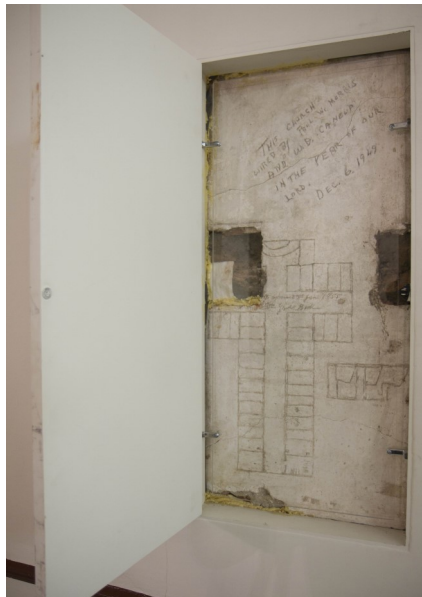
Protected behind Lucite are parts of the 1706 brick that comprise the north wall, Col. Bull's 1855 pew plan, and not to be outdone, graffiti-like inscriptions made by electricians Paul W. Morris and W. D. Caneup, who installed the first lighting in the church in 1949.

Using the north wall of the nave as his work space, Bull inscribed his pew plan in the plaster on January 2, 1855. It was first discovered during a 1948–50 restoration not long after the church was reopened after fifty-seven years of dormancy. Termites were found in the walls, and when the plaster was removed, Bull's plan was revealed. Then Morris and Caneup inscribed their names. Instead of restoring this part of the wall and making it visible, perhaps to cover over the new graffiti which the perpetrators likely thought would be lost to history, the wall was replastered and the Hastie monument installed over it.

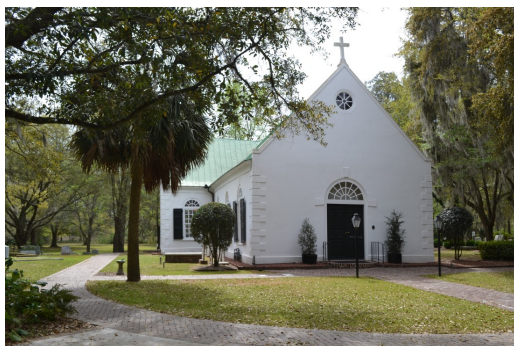
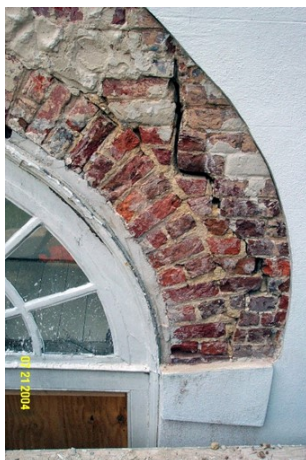
The walls of the 1706 church and its 1723 cruciform extension were made of brick set in English bond. A white stucco overcoat was applied shortly after the cruciform expansion to hide the differences between the older and newer brick. A stucco exterior was also considered more stylish, since it emulated a grander stone façade.

***Stucco walls (left) and brick under stucco during 2004 repairs on the west wall (right), courtesy of Richard Marks Restorations and Old St. Andrew's***

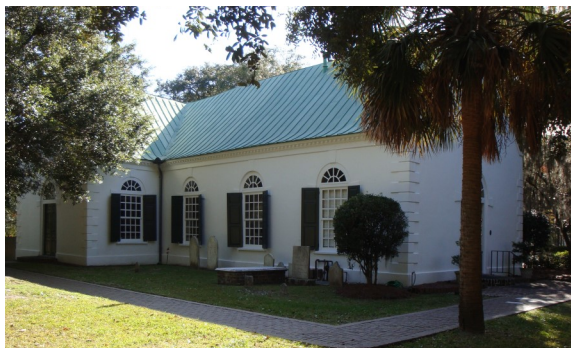
The roof has undergone a number of changes during the church's long life. It was made of pine in 1706, then of cypress when the church was expanded in 1723. The first photograph taken of the church (in 1891) and postcards from the first decade of the twentieth century show a roof of wooden shake shingles. In 1927 the Colonial Dames of South Carolina funded the replacement of the wooden roof with a metal one. A metal roof (first in red, then in green since 1960) has been part of the building ever since.

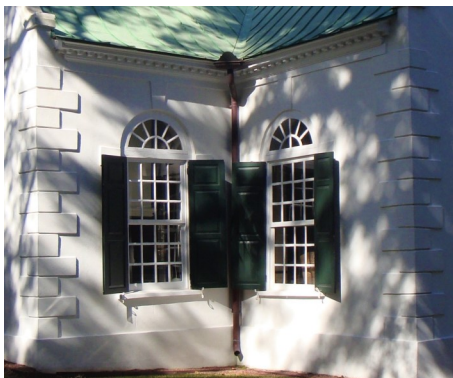
Rusticated quoins were originally added to the church when the walls were roughcast in stucco as part of the 1723 expansion. Quoins were added to the parish house to match the look of the church as part of a major refurbishment in 1977.

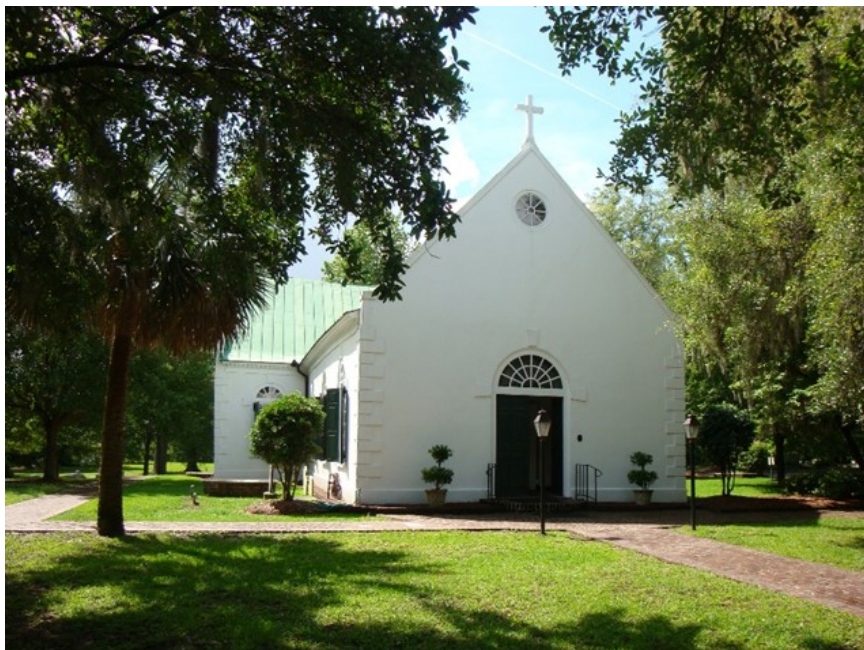
The white cross that sits atop the church's west gable is a relatively new addition to Old St. Andrew's, if you call within the last hundred years new. It was likely added in 1916 when the church was thoroughly repaired by the Diocese of South Carolina. Time has taken its toll, and the original cross, rotted beyond saving, was replaced in 2012.

Below the cross in the previous picture is a circular window. What's appeared or not appeared in this position has changed at least five times over the church's history since 1894. This information can be a handy guide to help estimate the date of an image from the church's exterior.

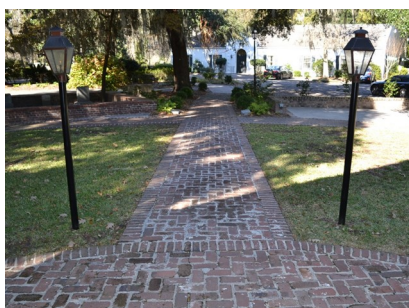
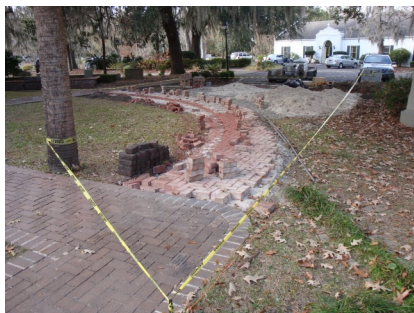
***Brick walkway to the prayer patios (left) and building the north patio, December 2012 (right)***

In 2006 the walkway was extended to connect the doors on the west and north sides. Personalized bricks were sold to help pay for the recent restoration. This area of the path was named Tompkins Walk after the eighteenth rector, Rev. George Tompkins, and a time capsule was buried under the bricks. In 2010 the walkway was extended on the west side through the parking lot to Magee House.

Prayer patios were added on the west side and dedicated to the memory of beloved parishioners Vivian Wilson-Cohen and Augusta Nadol in 2013–14.
