A Pictorial History of Saint Andrew's Parish Church

Volume II Interior

Interior of Old St. Andrews Parish Church. Built 1706 near Charleston, S. C.

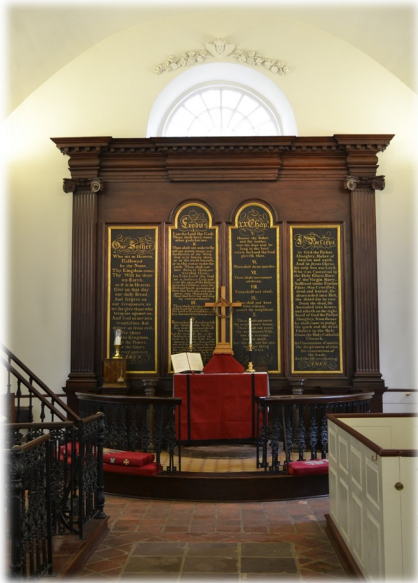
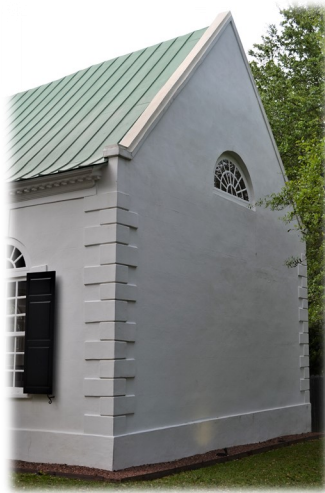
Reredos at the east end

A large vertical, rectangular window was set below the semicircular window until the fire destroyed it. Rather than replace it, restorers bricked in that section of wall and added the magnificent reredos to it. Without knowing the origin of the fire and reredos, the small window at the top of the wall seems out of place.

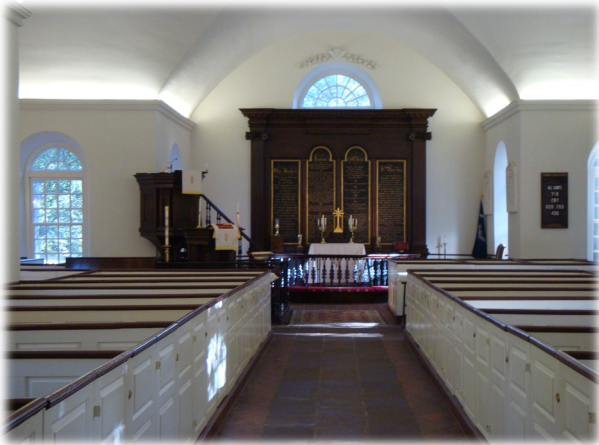
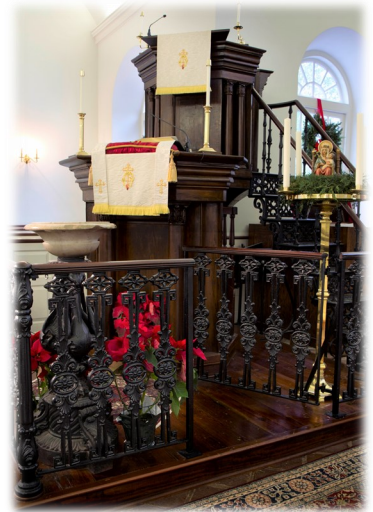
The high-backed colonial pews had deteriorated past the point of saving and were replaced by these more fashionable, lower-backed pews. Bull used the wall along the north side of the nave as his work area, etching his new pew plan in the plaster. Bull's plan wasn't discovered until 1950, when it was promptly covered with a memorial tablet dedicated to Drayton Franklin Hastie, a vestry member who fought to keep the church open until his death in 1916. The plan was rediscovered in the 2004-5 restoration, this time cleaned and preserved for viewing behind Plexiglas.

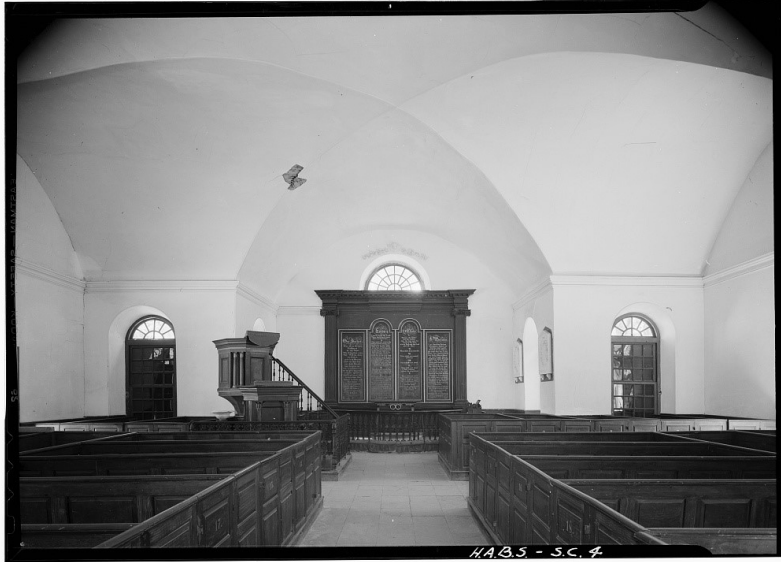
Top: East end with reredos, pulpit, reading desk, and barrel vaulted ceiling. Note the missing plaster on the ceiling.

St. Andrew's was one of thousands of buildings included in the nation's first federal preservation program, the Historic American Buildings Survey. A team of HABS employees, under the administration of the National Park Service, visited the church in March and April 1940. Nine photographs (five interior and four exterior, by C. O. Greene) and ten architectural drawings (six interior and four exterior) were produced that documented the condition of the church at that time.

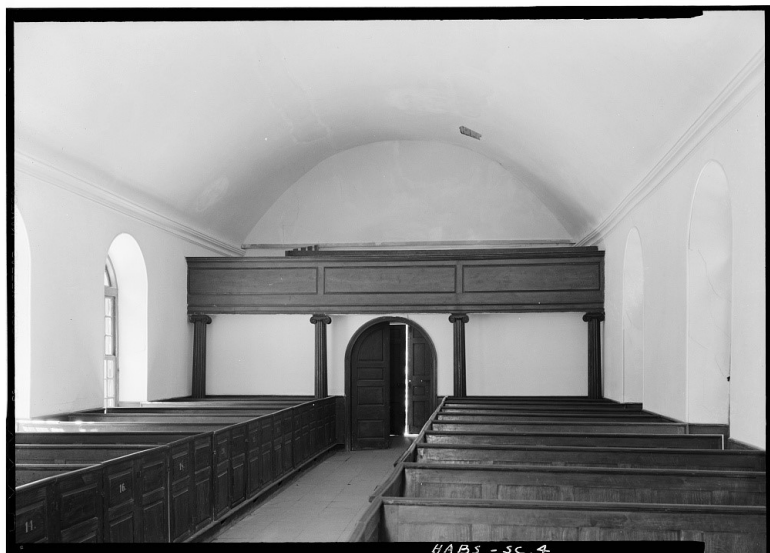
Bottom left: Balcony and west end. Again, plaster is missing on the ceiling.

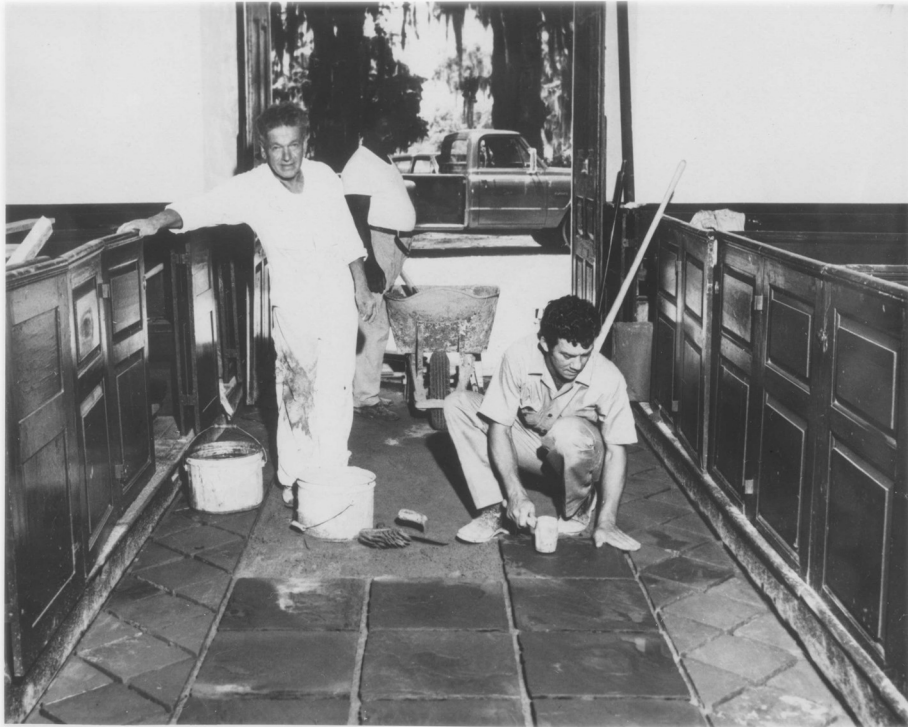
The church received a facelift in 1969, and in the process, made a startling discovery. The sandstone paver floor, as it became increasingly more and more uneven as the years went by, was removed and prepared for leveling. Underneath it in the dirt workers found three layers of stone and brick, which had been the materials previously used. Our best guess is that the stone and brick were of colonial origin and was replaced by Col. William Bull in his 1855 restoration. Thankfully, the old materials weren't thrown away but kept under the new sandstone paver floor. The stone and brick were now reused and mortared in place, with a Cross of St. Andrew laid at the crossing of the aisles and at the west entrance.

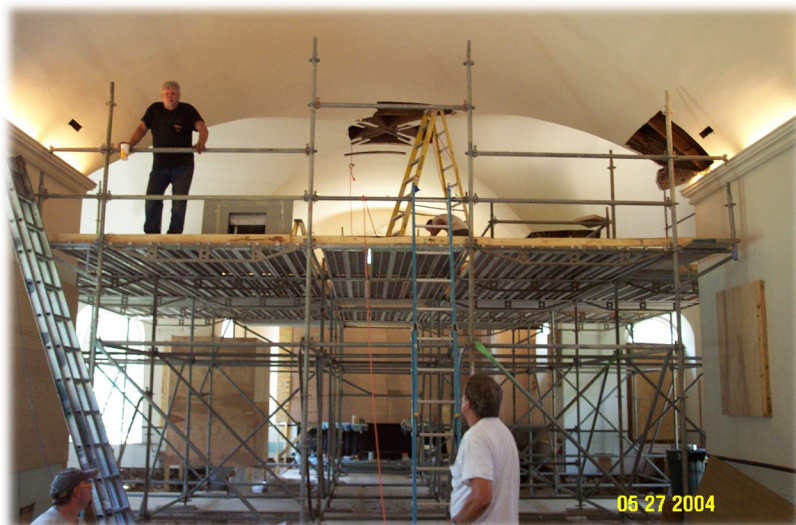
Note the center column that supported the weight of the rafters during repair (*at left*).

Note also the 1764 rafters pulled down for repair or discard (*at bottom right*). Parishioner David Seithel later used some of this wood for crosses sold as a fundraiser.

As Old St. Andrew's prepared for its tercentennial celebration in 2006, church leaders called in structural engineers to give the old building a thorough examination. The results were sobering. Differential building settlement had caused the walls to bow outwards. The collar-tied roof structure was failing, with ties pulled away from many of the rafters. These and a host of other issues caused the church to be closed for ten months in 2004-5.

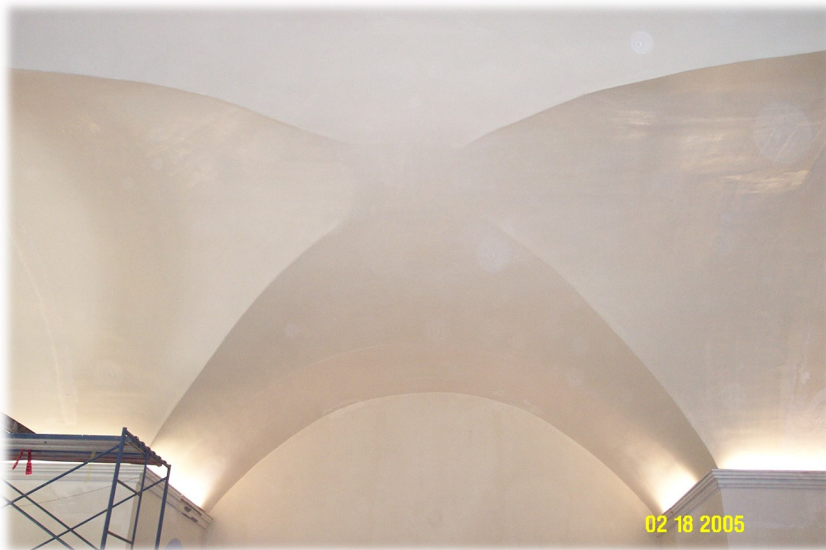
New steel lath ready for replastering.

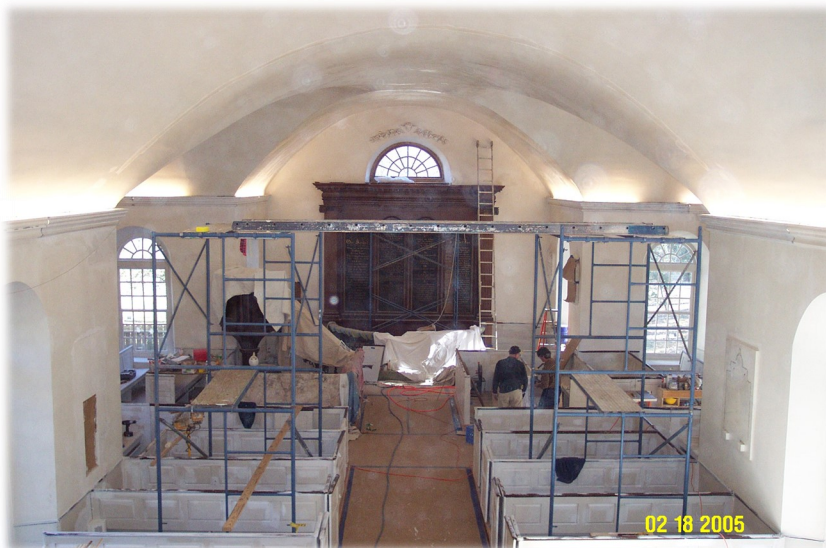
The finished product: newly-repaired barrel vaulted ceiling.

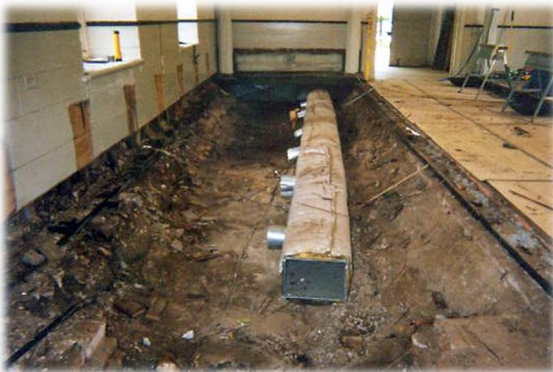
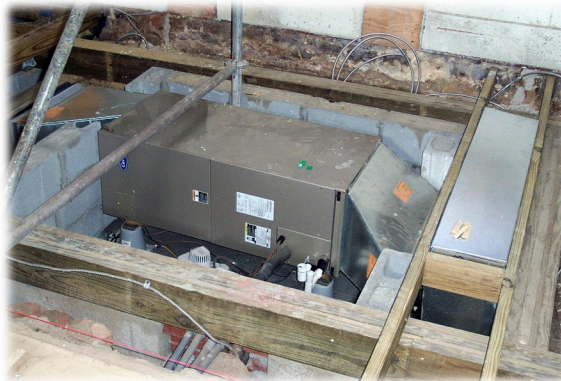
After the flooring was removed, an archeological investigation was undertaken that added new information to the church's history.

New HVAC system under the floors. Registers are now in the floors, and not in the ceiling.

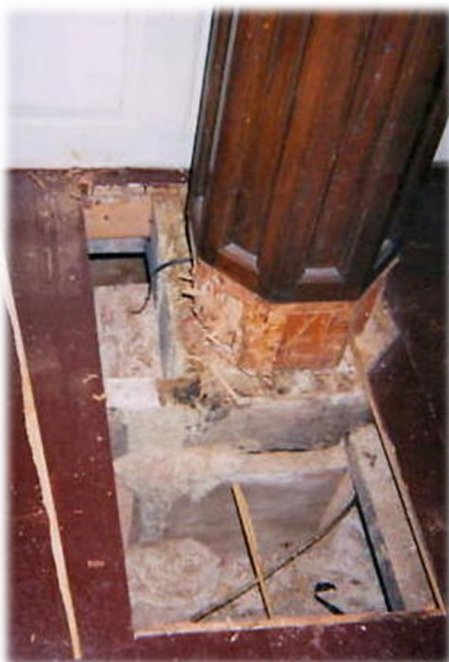
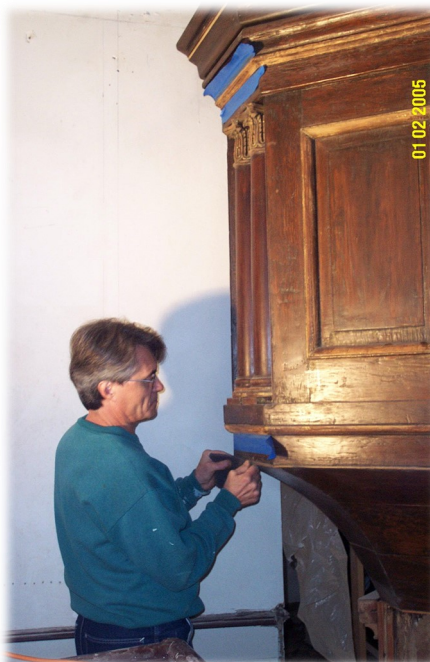
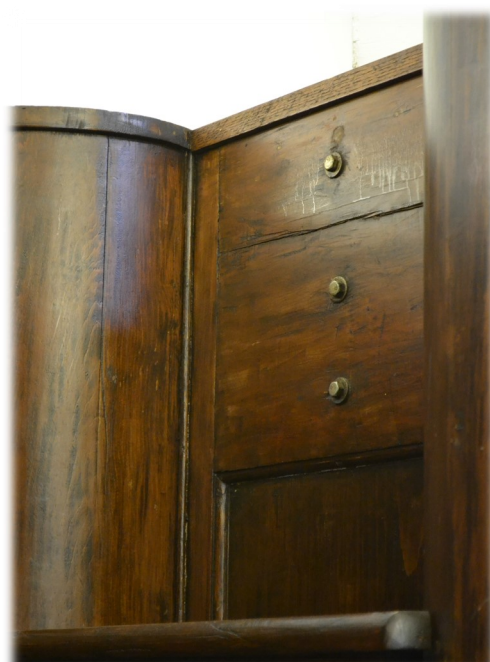
Pulpit repair, including fixing termite damage to the base and adding bolts to affix the top to the wall.
